A report on the comparative study of the durability of corn sieves in Kombinat Rolny Kietrz

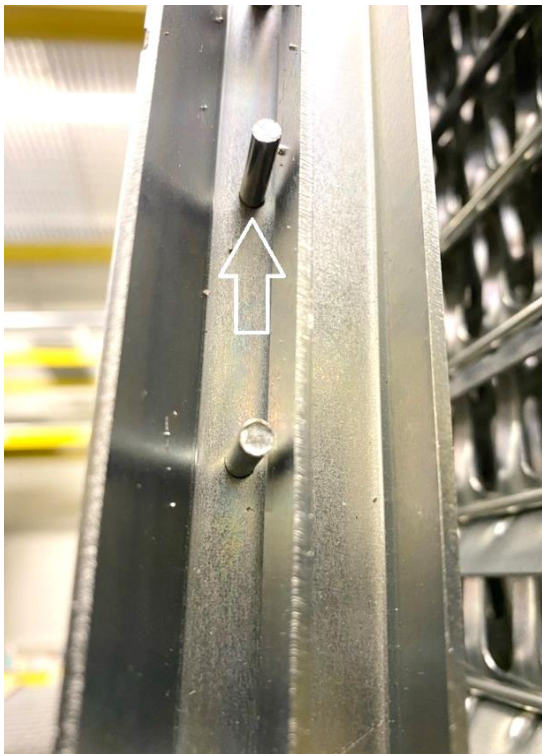
Photo 1 – The method of placing the lamella rotation axes in the calibrated hole

The first sieve has the lamella rotation axes placed in calibrated holes [Photo 1]; the second sieve in slide bearings made of plastic, resistant to acids and alkalis [Photo 2].

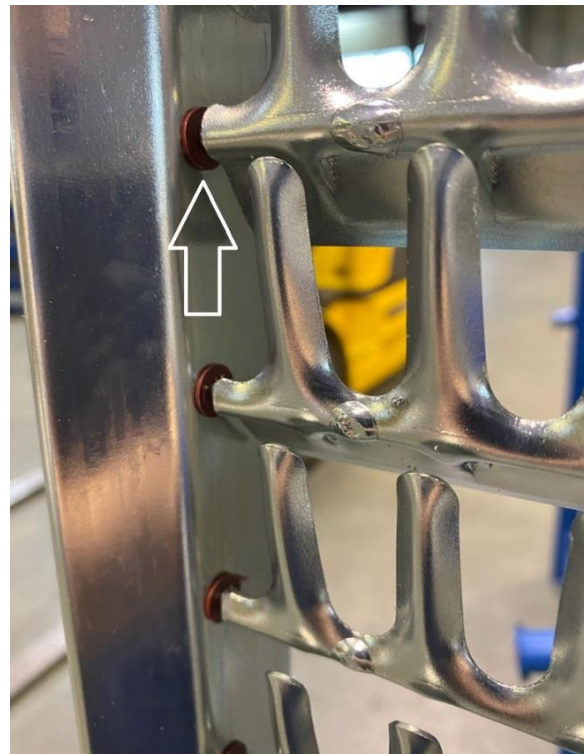
Photo 2– The method of placing the lamella rotation axes in slide bearing

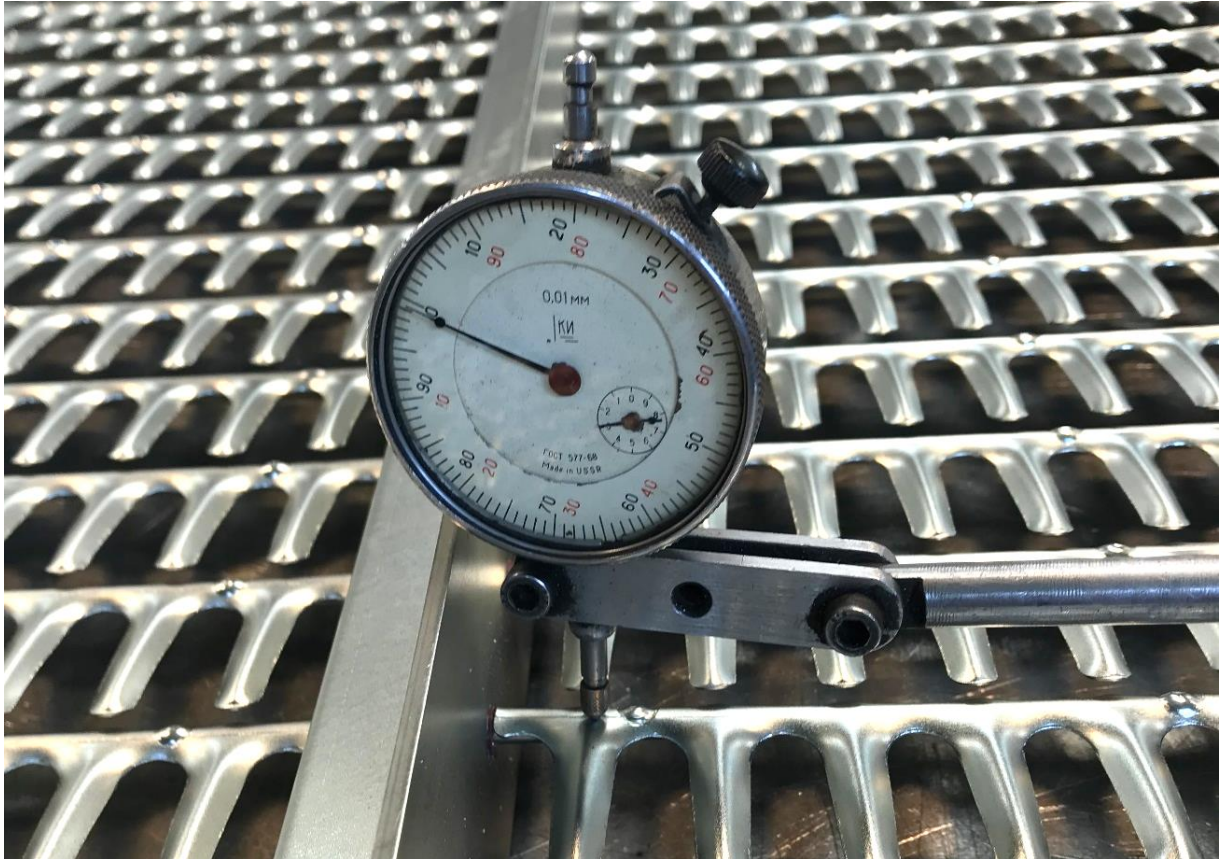
Photo 3- The method of measuring the clearance with a time sensor

The parameter to be assessed will be the clearance between the opening in the frame and the axis of rotation of the lamellas. The measurement points were permanently marked on both sieves and are measured with a time sensor [Photo 3].

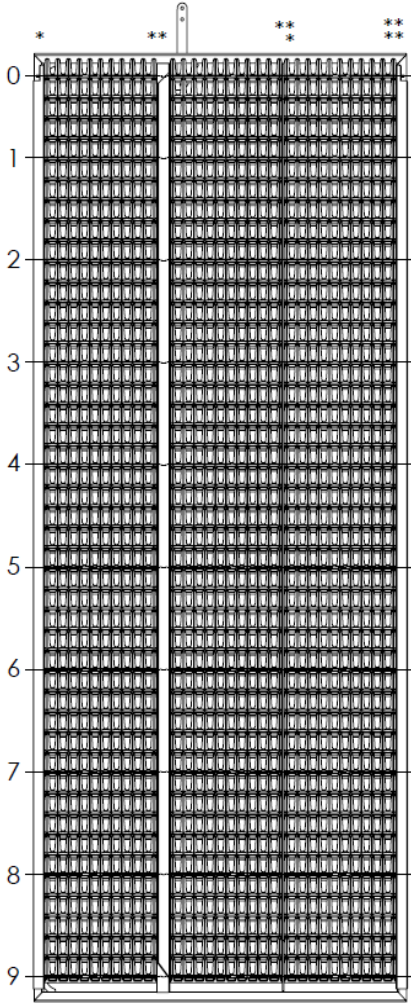
Table 1 – Clearance value [mm] in a brand new sieve with calibrated holes.

Measurement number	●	●●	●●●	●●●●
0	0,01	0,03	0,06	0,01
1	0,02	0,04	0,06	0,02
2	0,02	0,06	0,05	0,02
3	0,01	0,05	0,02	0,01
4	0,01	0,05	0,06	0,01
5	0,01	0,04	0,07	0,03
6	0,01	0,05	0,07	0,02
7	0,02	0,05	0,05	0,01
8	0,03	0,06	0,07	0,02
9	0,04	0,03	0,06	0,03

Medium clearance in a row: 0,018 0,046 0,057 0,018

Medium clearance over the entire surface: 0,03475 [mm]
Standard deviation: 0,020505 [mm]

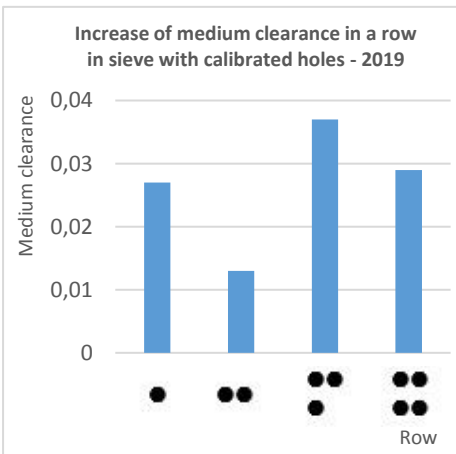
Diagram 1

The analysis of the clearance after the first year of operation does not give any grounds to indicate which structure gives hope for greater durability.

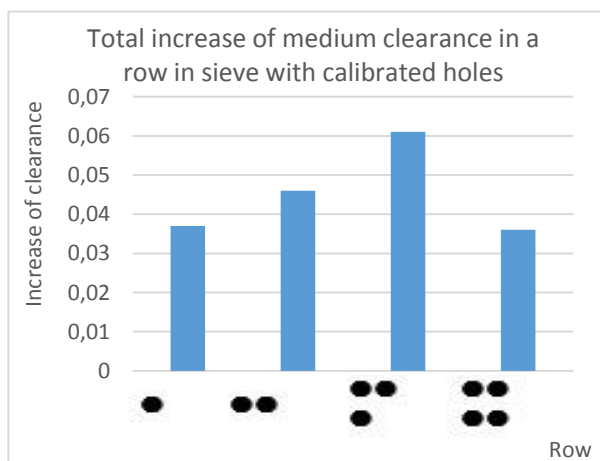
Diagram 3

In 2020, the combine harvested corn from an area of 552 ha. The mowing conditions were a bit more difficult than in 2019, because the grain humidity ranged from 28 to 34%, and the yield per hectare oscillated between 14 - 15 tons. During the corn harvest, there was one foggy day and one rainy day. The sieves worked properly in all weather and terrain conditions (mowing uphill and downhill). The only drawback was the sudden forward jerks - then the losses behind the sieve appeared. The values of the clearances at the checkpoints were measured and summarized in Tables 5 and 6, and the mean value of the increment of backlash in a row is shown in Diagrams 3 and 4.

The analysis of the clearances in the row and the diagrams 3 and 4 still does not allow for an unequivocal indication which sieve will have the greater durability. We noticed, however, that the average amount of clearance between the axis of rotation of the blades and the opening in the frame is smaller than between the axis of rotation of the blades and the opening in the partition. After the 2021 season, we will present the next measurement results and conclusions resulting from them.
