## Report

### from testing the prototype sieve in field conditions in the 2018 season

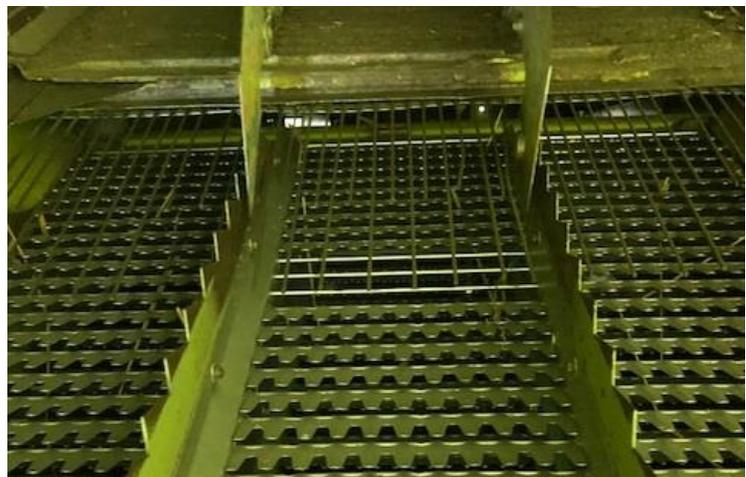
- 2) The second issue that creates problems is the durability of fixing the lamellas to the axis of rotation. The commonly used method of welding is sometimes unreliable (Phot.1). Breaking away from the axis of rotation is a big problem, because the lamella falls together with the grain into the grain elevator and causes its blockage or even more serious failure, when the sieve requires disassembly and specialized repair.

*Photo 1 A fragment of a damaged sieve, made by welding the lamella to the axis of rotation.*

The solution that we propose is the use of **hole welding** instead of spot-welding. This method gives a connection with much better strength parameters due to a larger weld cross-section (Photo 2) than a weld (Photo 3)

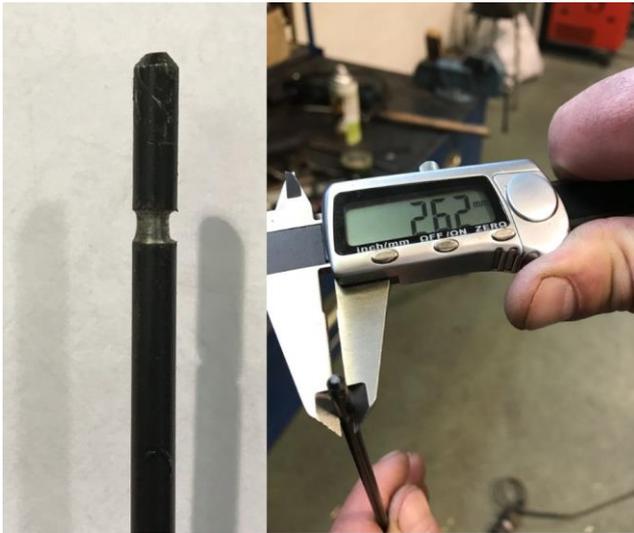
- 3) The third problem faced by farmers during the exploitation of sieves is their mechanical wear. It consists in wiping the axis of rotation of the lamellas (Photo 4) and wiping the holes in the frame (Photo 5).

Photo 4 The diameter of the axis of rotation of the lamella after removal from the frame (nominal diameter 3.8 mm).

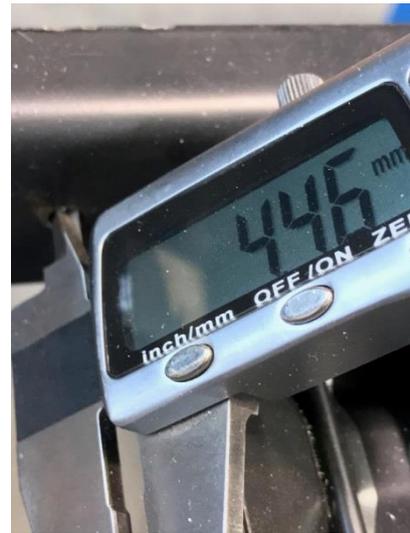
Photo 5 Diameter of the hole in the sieve frame (nominal diameter  $d = 3.9$  mm).

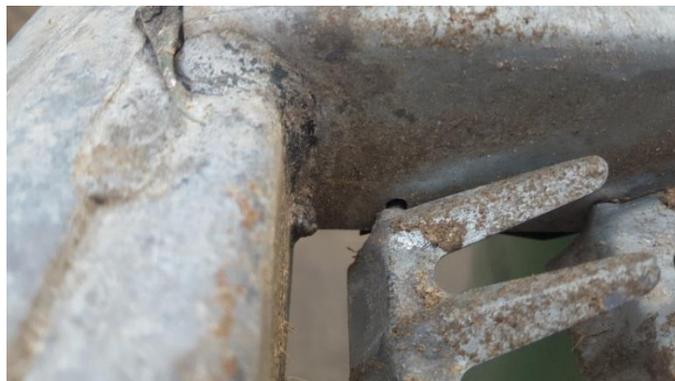
The basic factor that accelerates mechanical wear is the excessive clearance between the axis of rotation and the sieve frame (Photo 6).

Photo 6 Excessive clearance between the axis of rotation of the lamellas and the sieve frame in the sieve removed from the combine harvester.

It is assumed that the correct clearance should be  $L = 0.1 \pm 0.05$  mm. Achieving such a level of accuracy is quite difficult due to the fact, that on 1 m<sup>2</sup> of sieve, there are about 100 - 150 connections. The solution that we propose is use the plastic **plain bearings** (Fig.3).

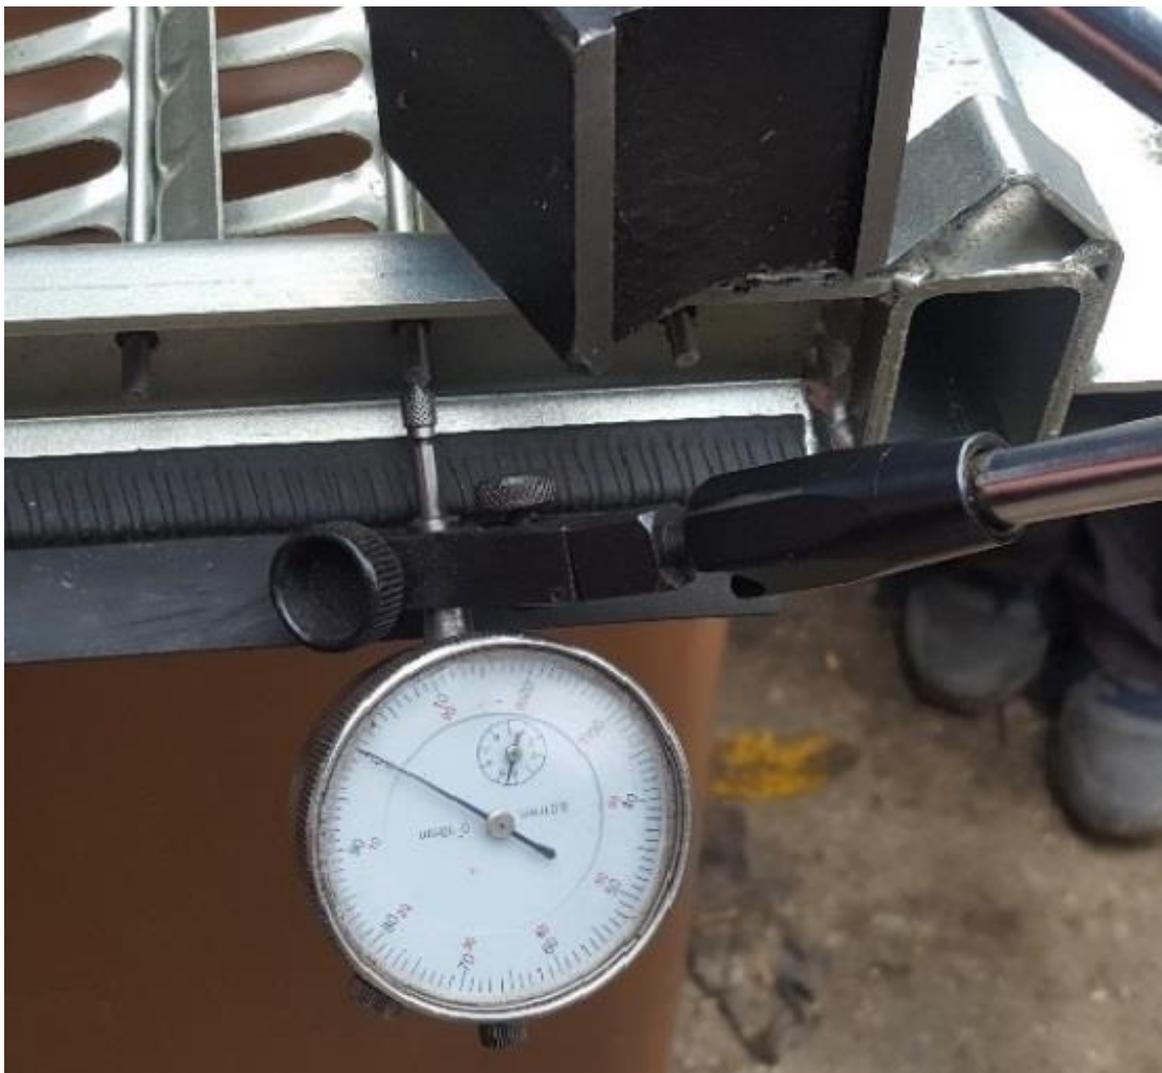
During the entire period of use in 2018, the sieve worked about 160 hours. After the end of the season, it was disowned, carefully examined and has been tested. The external examination did not show any cracks or micro cracks within the sieve frame, as well as within 945 holes of the lamellas welds fixing the lamellas to the axis of rotation. Separate tests were carried out on the clearance between the axis of rotation of the lamellas and the sliding bearing. The losses created during operation were measured using a dial indicator attached to the sieve frame. The attached sensor was zeroed in the position of the lower axis of rotation (Photo 7),

*Photo 7 Zero sensor in the lower position of the lamella rotation axis.*

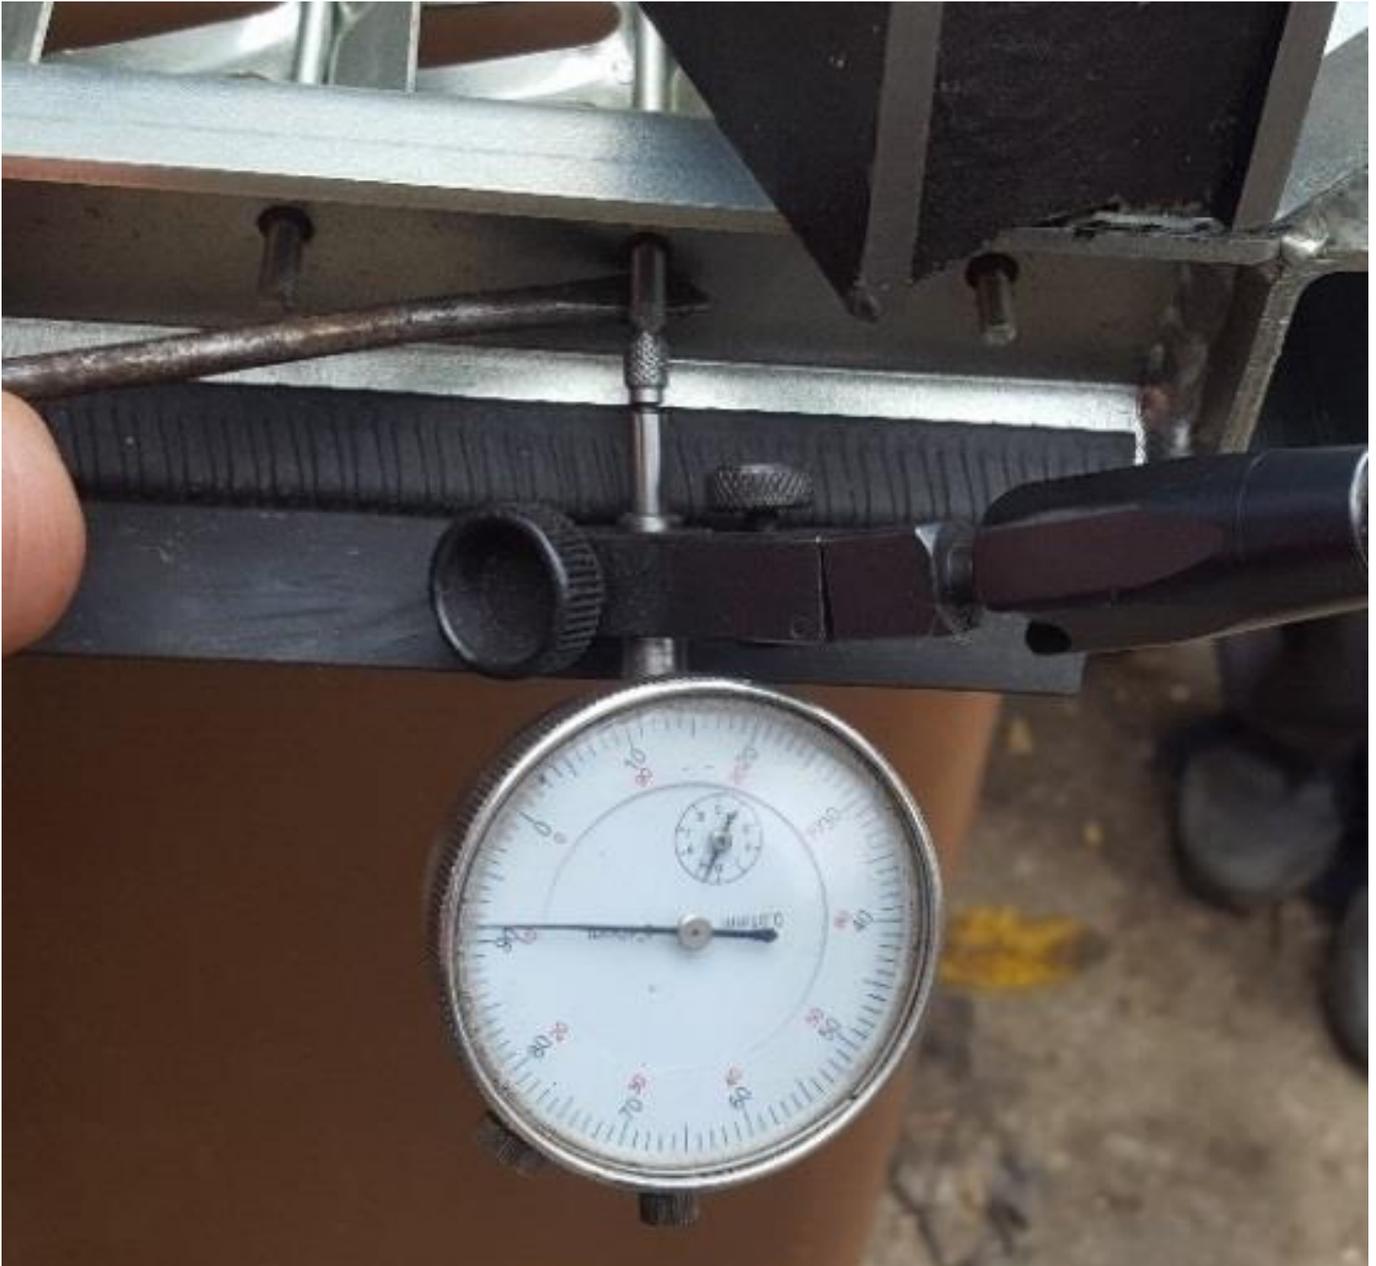
and then the axle was raised to the upper position using a screwdriver (Photo 8).

*Photo 8 The sensor indicates a deviation of 0.09 mm. in the upper position of the axis of rotation of the lamellas.*

The above test has been repeated many times at various sieve points. The measured clearance was in the range of  $L = 0.03$  mm. up to  $L = 0.09$  mm. This is much less than the clearance allowed in the brand new sieve (clearance according to the works standard is  $L_{\max} = 0.15$  mm).

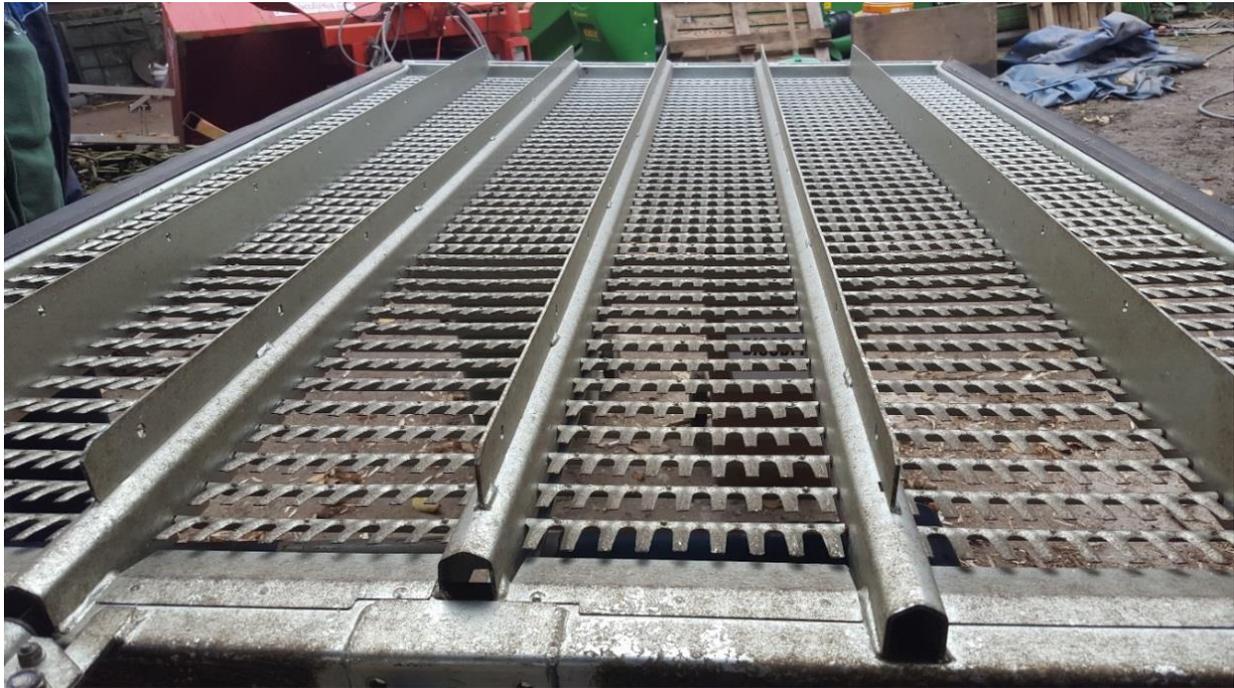
- 
- 2) The use of hole welds instead of spot-welds for installing lamellas to the axis of rotation increases their mechanical strength, protects against falling off and from changing position relative to the axis of rotation. The sieve after working for about 160 hours continues to close on the entire surface evenly (Photo 9),

*Photo 9 Sieve with CZ3m lamella with the first closed section and the second open section at 12 mm. - after 160 hours of work.*

The experience gained during using sieves with hole-welded lamellas allows the recommendation of **hole welding** as a more durable and more reliable solution in all types of lamellas.

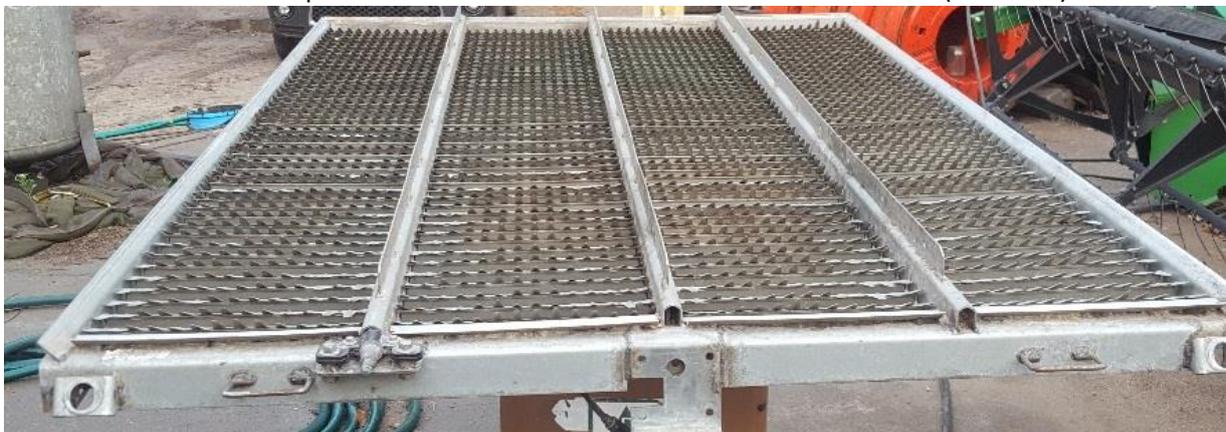
which was impossible to achieve in the sieve with welded lamellas (Photo 10).

*Photo 10 Sieve with CZ3 lamella with visible deformation of lamellas after 140 hours of operation.*
